# Manhole Inspection Summary

Manhole # S19I\_\_041MH

Insp Date: **2/29/08 12:54 PM**

**Location** Address: **16 calverton st**

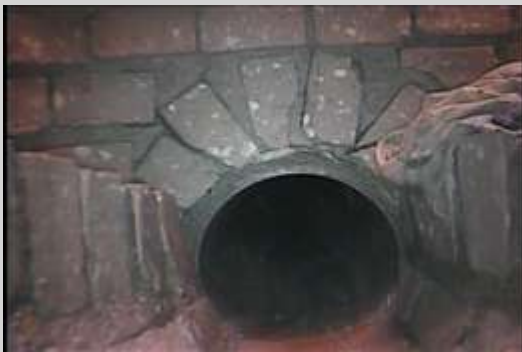
12 O'Clock Outflow

8 in. Circular Gravity Sewer  
Pipe Out @ 12 OClock

Pipe Height: **8.4** (in.) Rod and Bar (Angled)  
Pipe Material: **Clay** ☐ Pipe Lined  
Invert Depth: **10.99** (ft.) Flow Characteristics: **Slow**  
Deposits: ☒ None ☐ Mud ☐ Sludge ☐ **Debris** ☐ Grease  
Silt Depth: **0** (in.) Deposits Extent:  
Infiltration: **None** Pipe Seal Cond: **Sound**

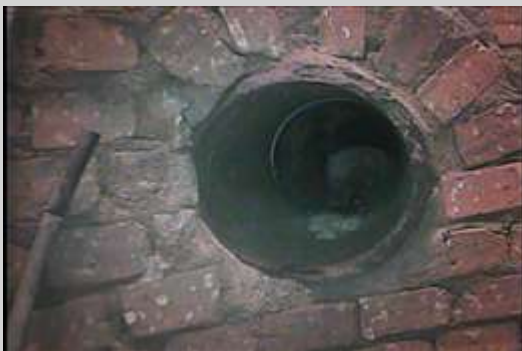
6 O'Clock Inflow

8 in. Circular Gravity Sewer  
Pipe In @ 6 OClock

Pipe Height: **8.4** (in.) Rod and Bar (Angled)  
Pipe Material: **Clay** ☐ Pipe Lined  
Invert Depth: **8.04** (ft.) Flow Characteristics: **Fast**  
Deposits: ☒ None ☐ Mud ☐ Sludge ☐ **Debris** ☐ Grease  
Silt Depth: **0** (in.) Deposits Extent:  
Infiltration: **None** Pipe Seal Cond: **Sound**

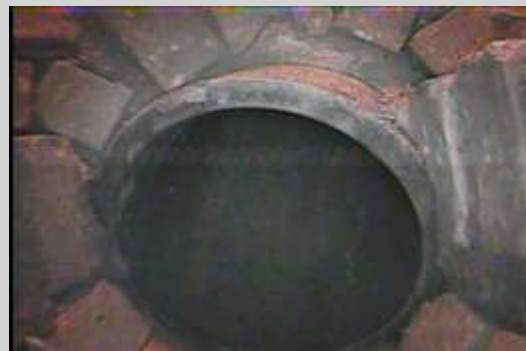
Drop In @ 6 OClock

Drop: **Outside** Rod and Bar  
Angled: **Yes** Reading: **9.54** (ft.)  
Inv Depth: **10.54** (ft.)  
Drop Condition: **Open**
